# RETROFITTING AND REHABILITATION MASONRY STRUCTURES

K.Ganesh ,S.Bharad

**ABSTRACT:** *Masonry is widely used type of construction in the world. But these walls are built with no seismic loading requirements and they are not capable of dissipating energy through inelastic deformation during earthquake. Recent earthquakes have shown that many such buildings are seismically vulnerable and should be considered for retrofitting.*

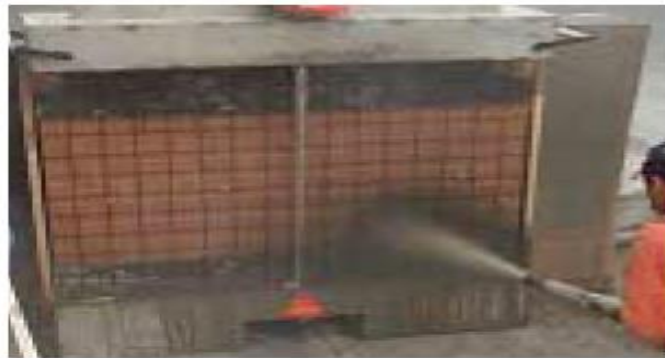
- 2) Shotcrete: Shotcrete overlays are sprayed onto the surface of a masonry wall over a mesh of reinforcing bars of 6-13 mm diameter @ 25-120.

*Fig3-shotcrete method.*

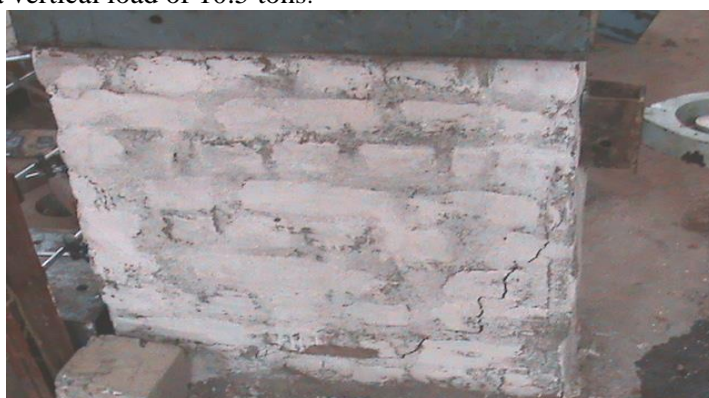
Minor cracks appeared at vertical load of 7 tons corresponding to a compressive stress of 40.18 kN/m<sup>2</sup> . This cracks caused the crushing of bricks along fourth wythe and completely collapsed at a vertical load of 10.5 tons.

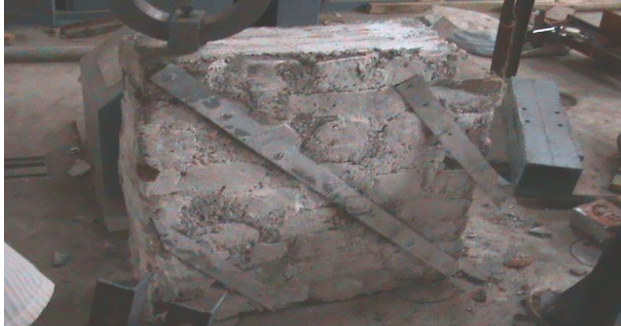
Minor cracks appeared at 13 tons corresponding to the compressive stress of 74.37 kN/m<sup>2</sup>.The plane of failure is along the second wythe extending from right to centre as shown in figure. The failure is not sudden and good composite behaviour is observed due to presence of steel strips.

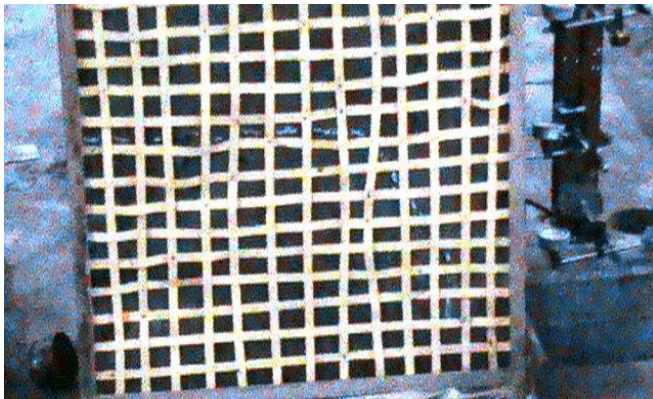
Minor cracks appeared at vertical load of 9 Tons corresponding to a compressive stress of 51.48 kN/m<sup>2</sup>. The plane of failure is along the third wythe extend to the bottom of the wall. The failure is not sudden and good composite behavior is observed due to presence of polypropylene fibre.
